Internal Task Force

Tom Røtjer, Head of Internal Task Force
9 April, 2018

The refining process to extract alumina

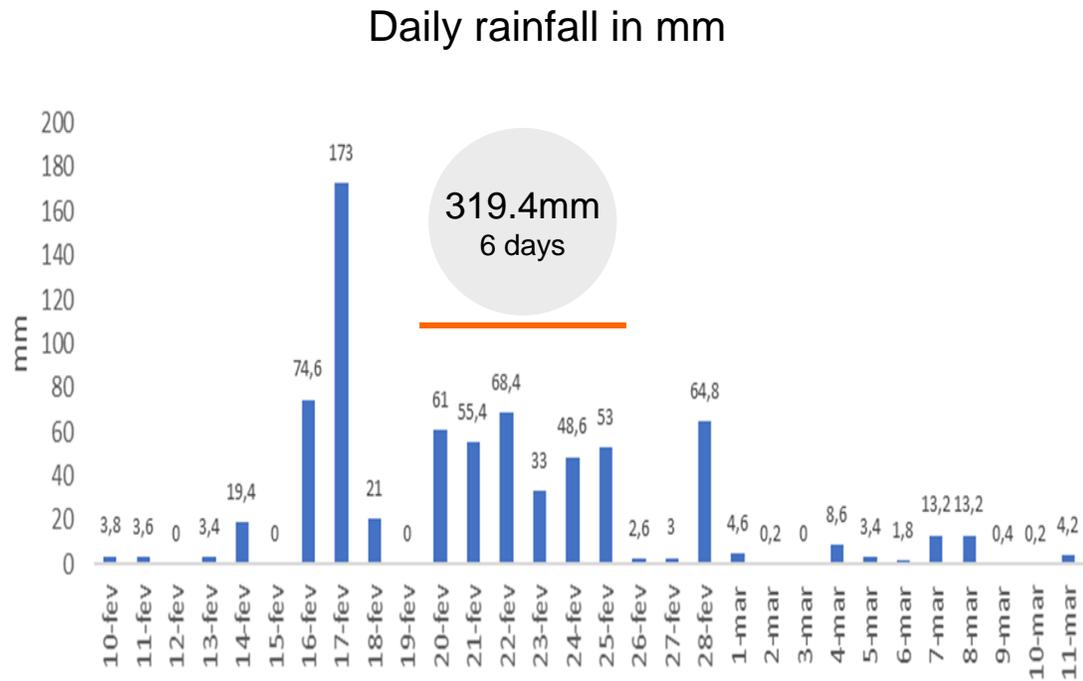
Rainfall volumes

The event of intense rainfall 16-17 February 2018 resulted in 231mm in 12hr and 239mm in 24hr. Total February rainfall was 901mm

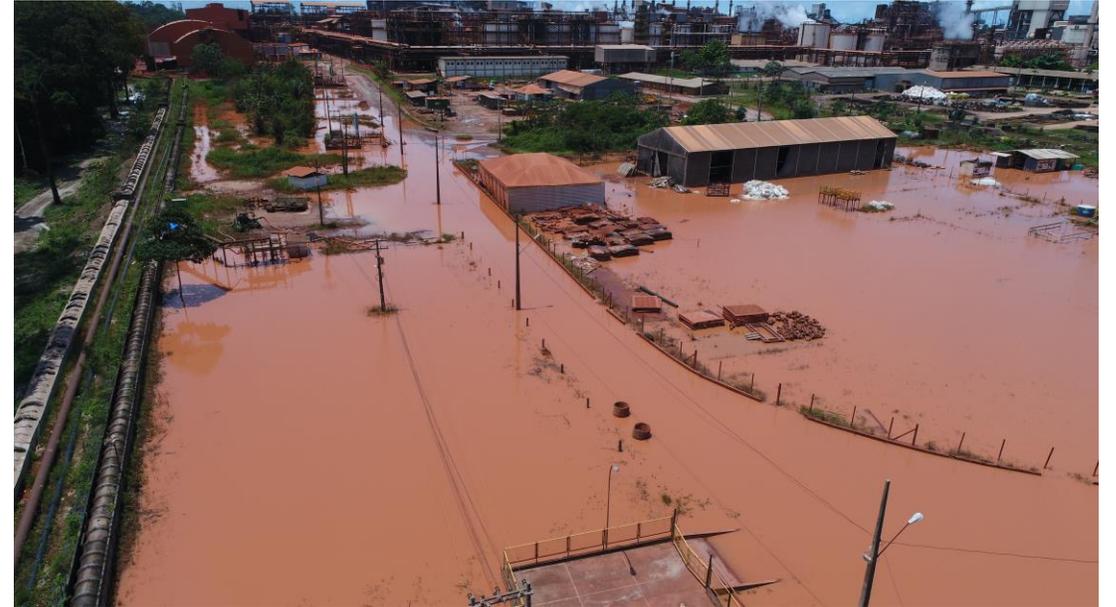
Area 45 storm water flooding

Flooding contained within the walls of the surrounding pipe channels

- Used for contractors and laydown area.
- As part of the Alunorte Water Management improvement project that is already sanctioned, a new storm water system including new holding pond and sufficient pumping system will be constructed in Area 45

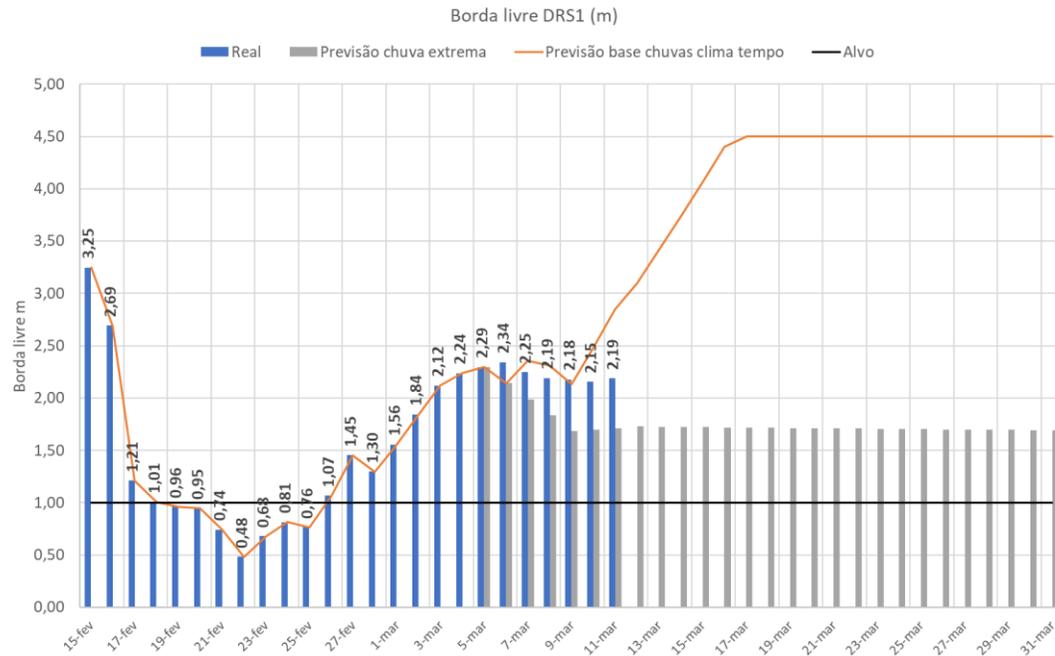
Freeboard development during event

No overflow from DRS1

- Water retained in DRS1 in order to let Effluent Treatment Plant prioritize plant area

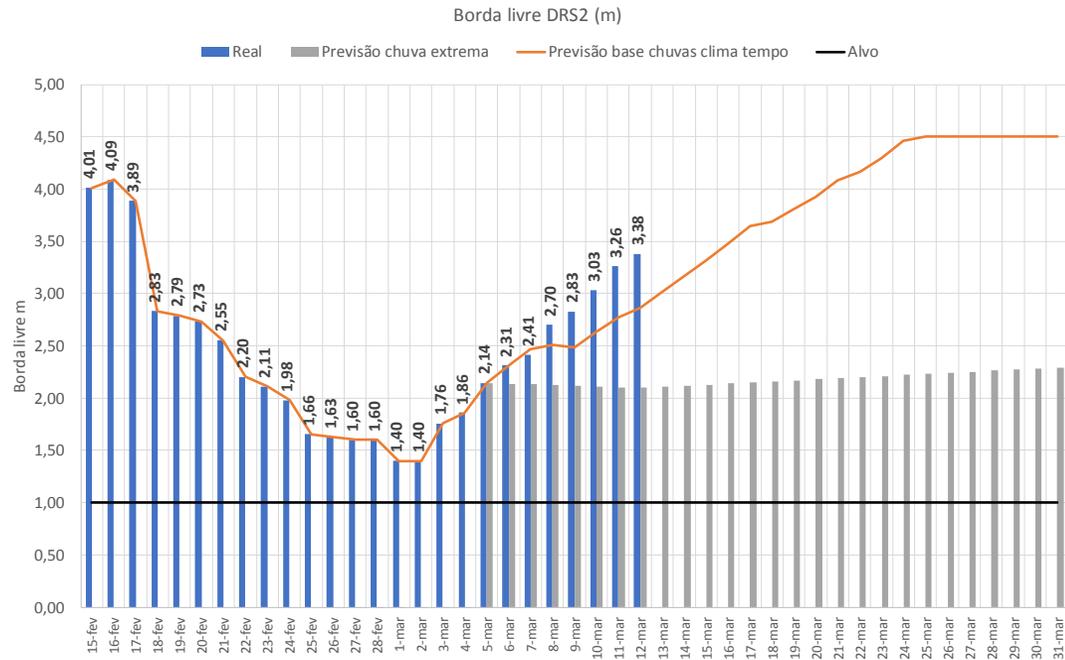
Freeboard development during event

No overflow from DRS2

- DRS2 had good capacity, and DRS2 basins contributed to relieving pressure on DRS1

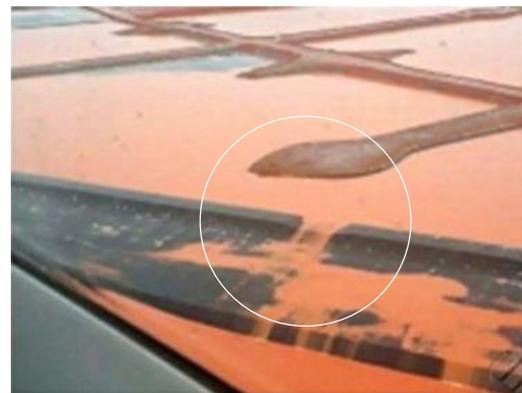
Alleged «overflow» - photo «evidence» used in media to «prove» spillover from DRS2.

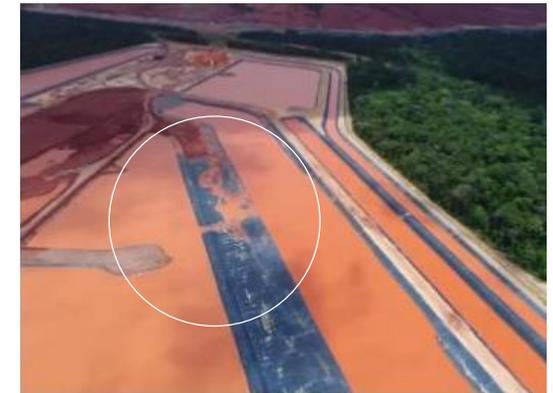
The same «overflow» showing that water moves from a dry zone to a wet zone within the deposit, as it is supposed to.
