Internal Task Force

Tom Røtjer, Head of Internal Task Force
9 April, 2018

The refining process to extract alumina

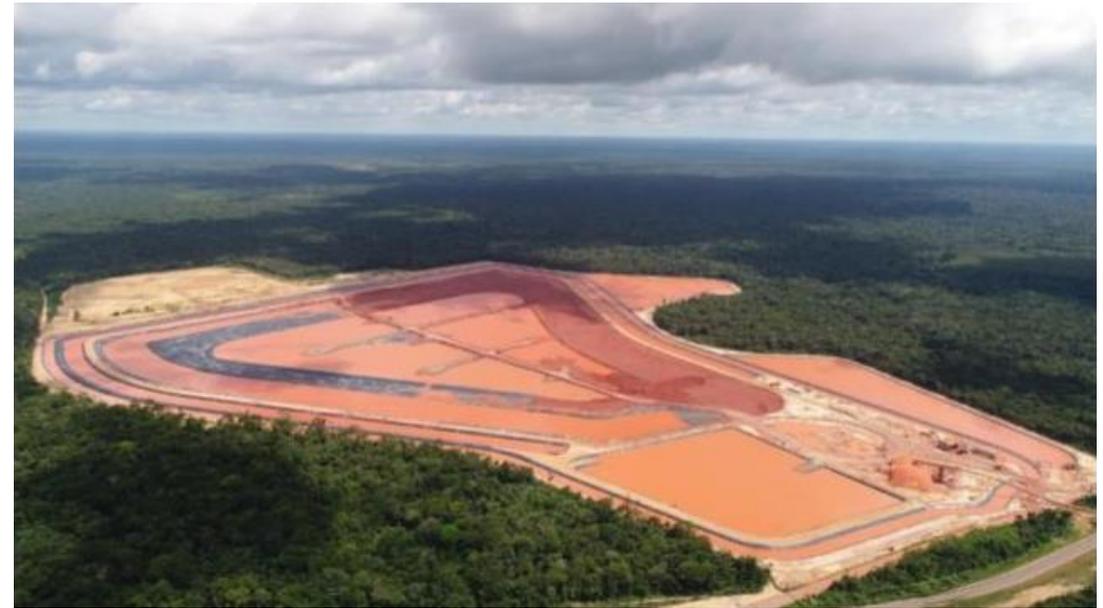
Alleged «overflow» - photo «evidence» used in media to «prove» spillover from DRS2.
