Global Industry Standard
on Tailings Management
(GISTM)

Public Disclosure

Annual Report 2024

Introduction

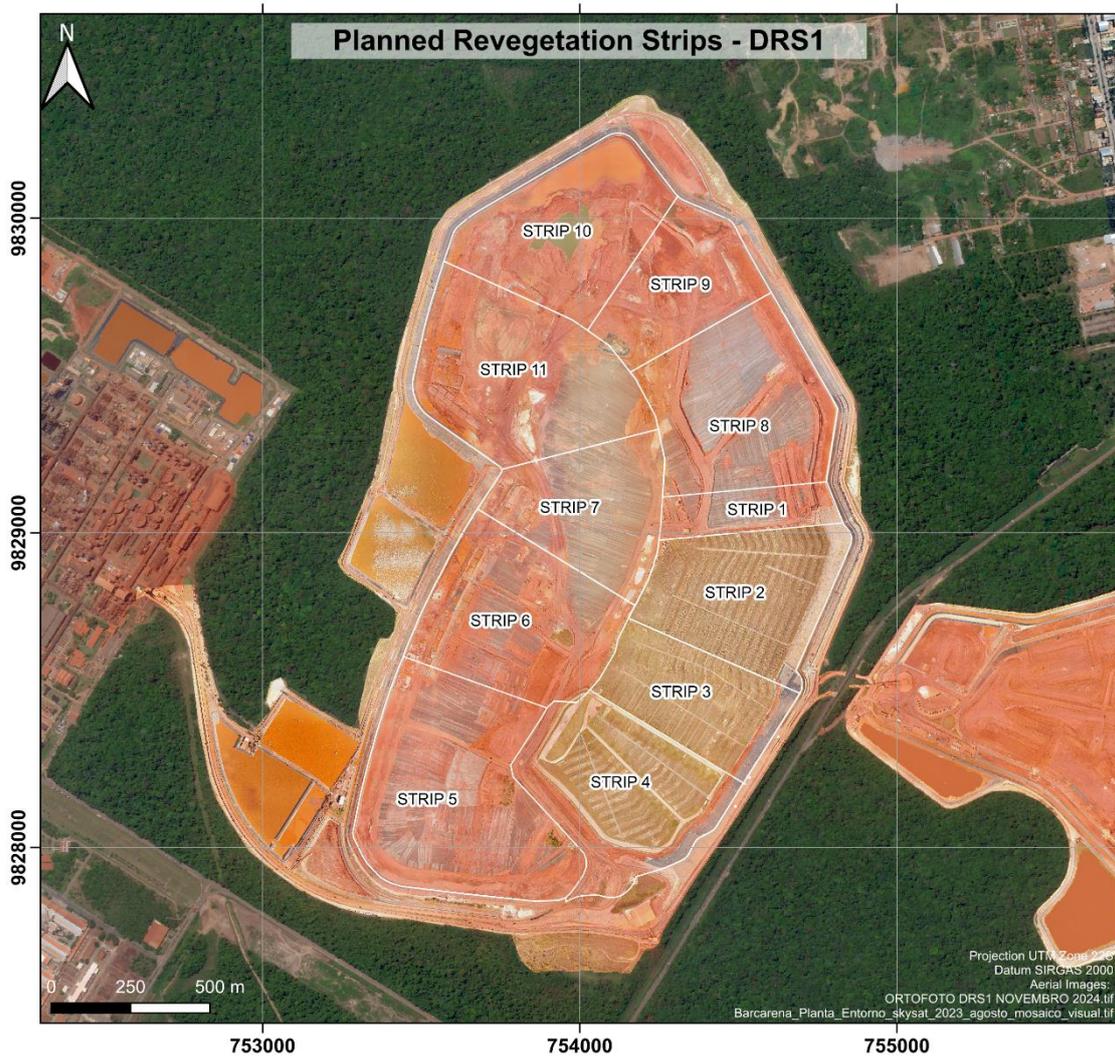
The closure is divided in 11 strips of rehabilitation. The strips 2, 3 and 4 have been rehabilitated, and represent approximately 60 ha. The design considers cap and store the filtered residue with cover systems consisting of HDPE geomembrane to lining the stored residue, covered by a densified soil, and revegetation of the surface.

The image below shows the configuration of DRS1 with the proposed revegetation strips.

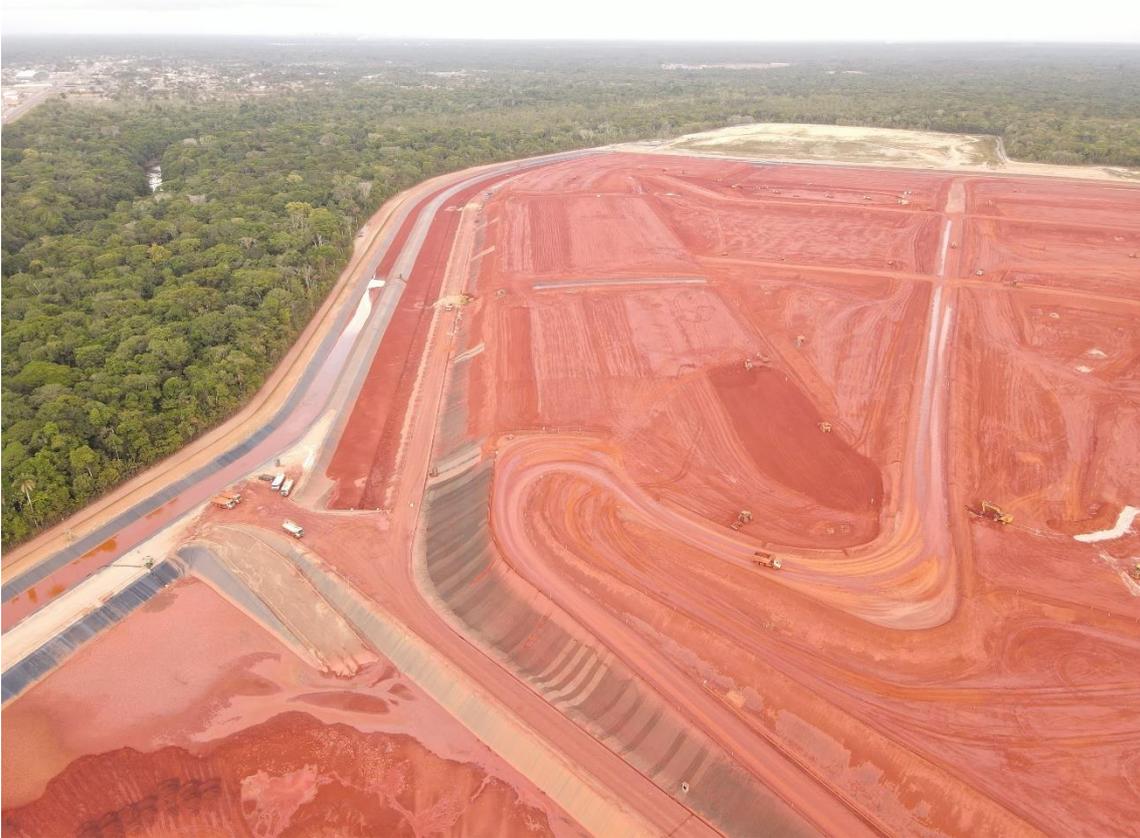
The dry-filtered residue stack DRS2 was constructed in 2015. The facility was designed and built as the DRS1 was approaching the end of its lifecycle. The DRS2 is a dry stack designed to store compacted press filter residues generated from the bauxite refining process for alumina production.

DRS2 is located at the east of the Alunorte refinery, in Barcarena, in the state of Pará, approximately 120 km from Belém.

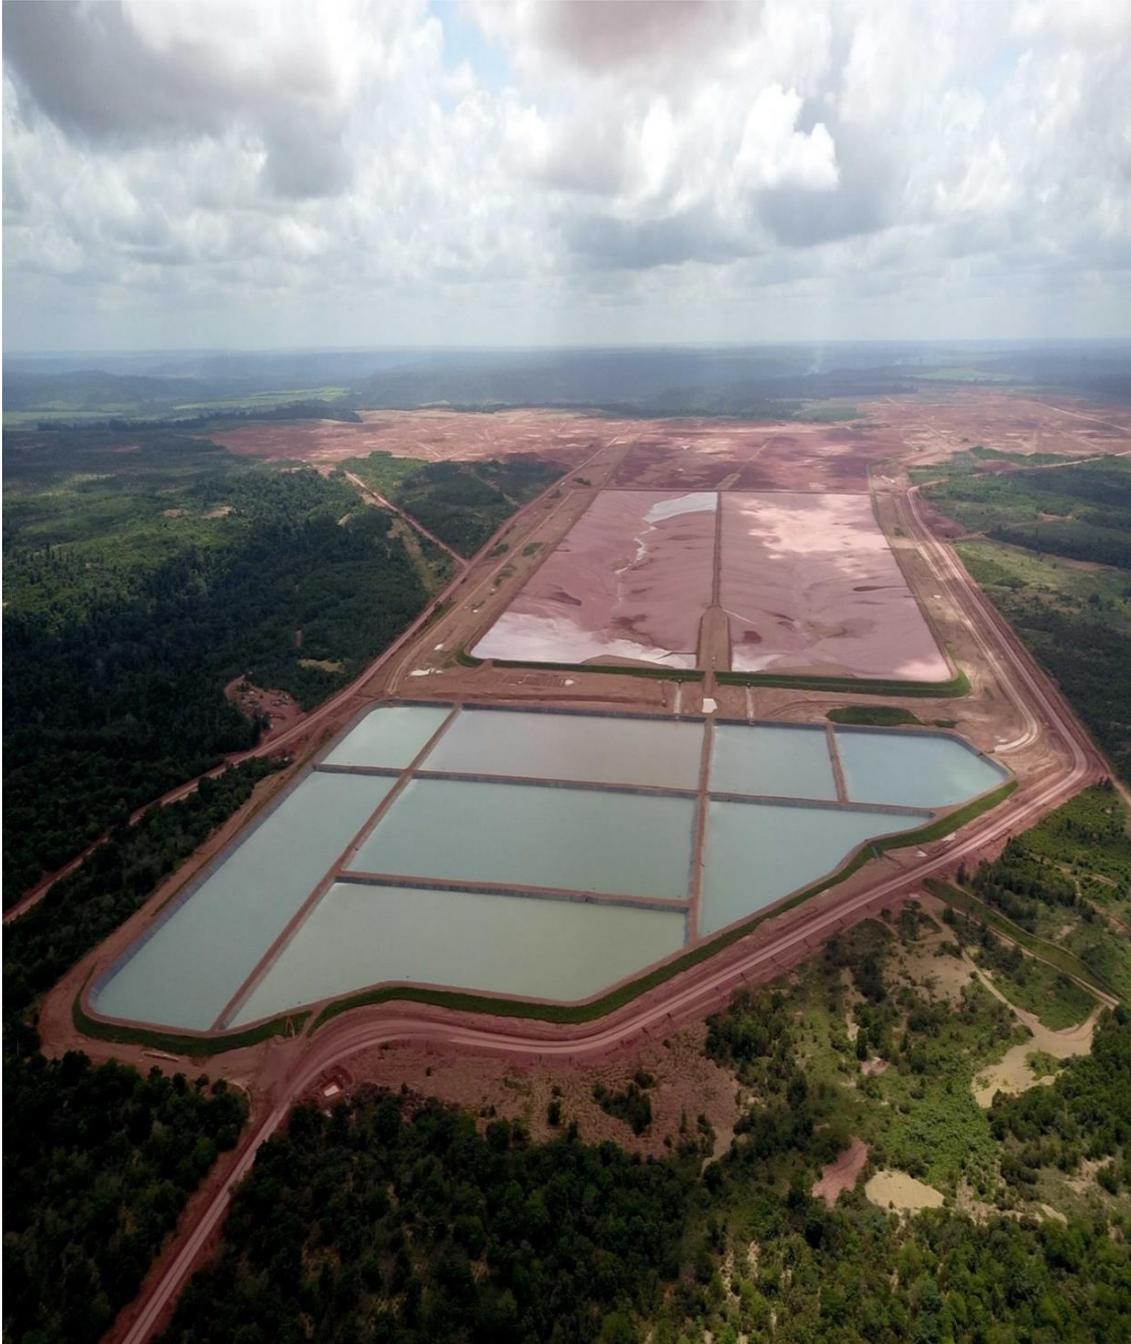
TDA (previously named RP1)

The TDA of Mineração Paragominas S.A. consists of four disposal quadrants (TDA-A, TDA-B, TDA-C, and TDA-D) delimited by internal and peripheral dikes and is responsible for the temporary drying of the tailings generated from the beneficiation of bauxite ore.
